Camelot Home Inspections, Inc.
10 Public Square
Willoughby, Ohio 44094

Property Condition Report

1234 Main St.
Mentor, OH 44060

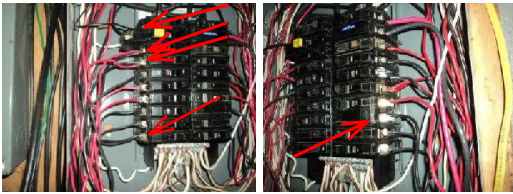
Breakers: CU/AL - Double tap wiring on #1,5,7,12,21:fire hazard, Contact a qualified electrician for further evaluation:breaker connections appear to be rated for 2 wires but label rating reads 1

1. Basement Electric Panel Breakers: CU/AL - Double tap wiring on #1,5,7,12,21:fire hazard, Contact a qualified electrician for further evaluation:breaker connections appear to be rated for 2 wires but label rating reads 1

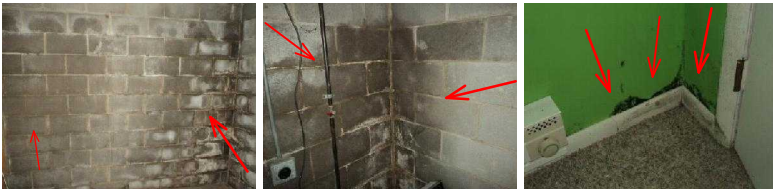
| <input type="checkbox"/> | <input type="checkbox"/> | <input type="checkbox"/> | <input type="checkbox"/> | <input checked="" type="checkbox"/> | Moisture Location: Walls - Water stains present mostly in n.e. corner and front south wall adjacent garage:active, Mold present on floor joists:potential health concern |

7. Main Basement Moisture Location: Walls - **Water stains present mostly in n.e. corner and front south wall adjacent garage:active, Mold present on floor joists:potential health concern**
